Manhole Inspection Summary

Manhole # S21E1_004MH

Insp Date: **5/21/08 2:27 PM**

Location Address: **2304 atlantic av**

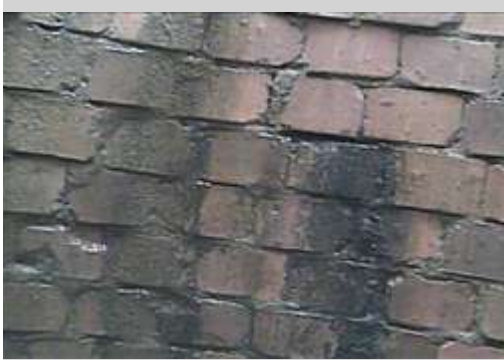
Defect 6

Infiltration: ☐ None ☐ Joint ☐ Cracks ☐ Mortar ☐ Roots ☒ **Wall**

infiltration @ barrel wall

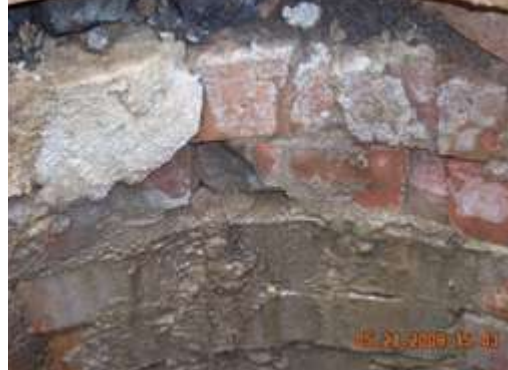
Defect 5

Condition: ☐ Sound ☒ **Cracked** ☐ Root Intrusion ☐ Loose Brick ☐ Deteriorated

cracked corbel bricks

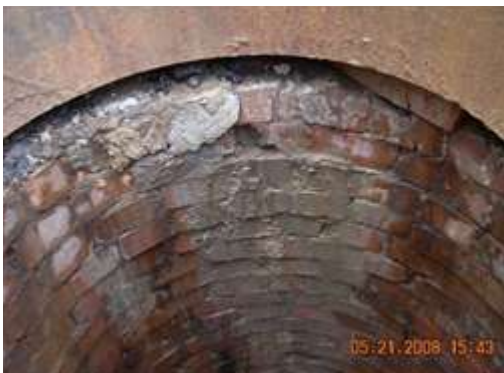
Defect 4

Infiltration: ☐ None ☒ **Joint** ☐ Cracks ☐ Mortar ☐ Roots ☐ Wall

infiltration @ chimney/frame joint

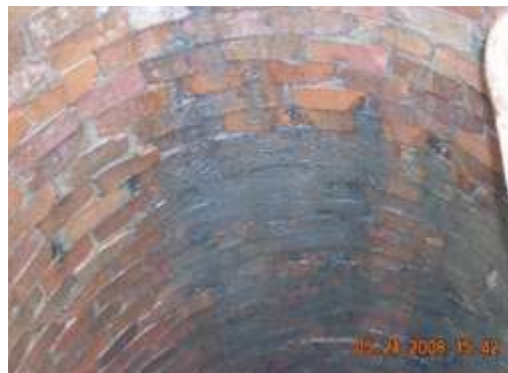
Defect 3

Infiltration: ☐ None ☐ Joint ☐ Cracks ☐ Mortar ☐ Roots ☒ **Wall**

infiltration @ corbel wall

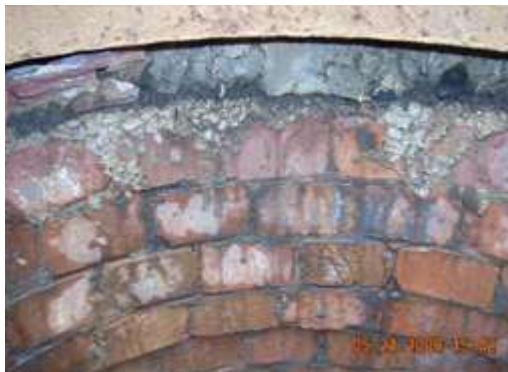
Defect 2

Condition: ☐ Sound ☐ Cracked ☐ Root Intrusion ☐ Loose Brick ☒ **Deteriorated**

deteriorated chimney

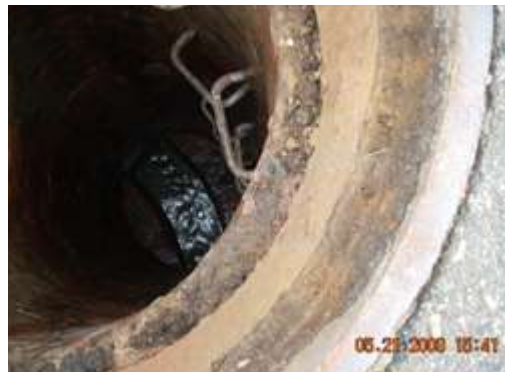
Defect 1

Frame Offset: **1** (in.) Condition: ☒ Sound ☐ Cracked ☐ Leaks

frame offset

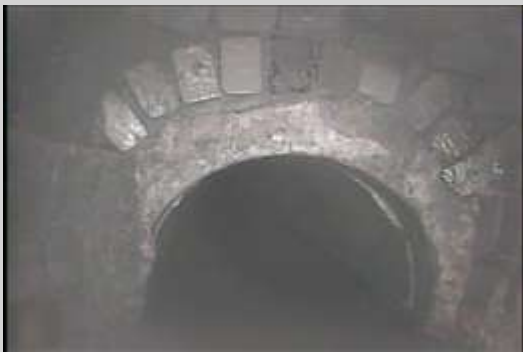
12 O'Clock Outflow

18 in. Circular Gravity Sewer
Pipe Out @ 12 O'Clock

Pipe Height: **18** (in.) Rod and Bar (Angled)
Pipe Material: **Clay** ☐ Pipe Lined
Invert Depth: **17.72** (ft.) Flow Characteristics: **Slow**
Deposits: ☒ None ☐ Mud ☐ Sludge ☐ Debris ☐ Grease
Silt Depth: **0** (in.) Deposits Extent:
Infiltration: **None** Pipe Seal Cond: **Sound**

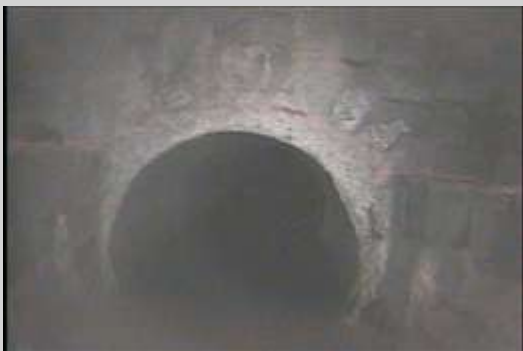
7 O'Clock Inflow

18 in. Circular Gravity Sewer
Pipe In @ 7 O'Clock

Pipe Height: **18** (in.) Rod and Bar (Angled)
Pipe Material: **Clay** ☐ Pipe Lined
Invert Depth: **17.54** (ft.) Flow Characteristics: **Slow**
Deposits: ☒ None ☐ Mud ☐ Sludge ☐ Debris ☐ Grease
Silt Depth: **0** (in.) Deposits Extent:
Infiltration: **None** Pipe Seal Cond: **Sound**
